Investigations of Failures of Epoxy Polymer Overlays in Missouri

Prepared by
Missouri Department
of Transportation

RI06-020

November 2007

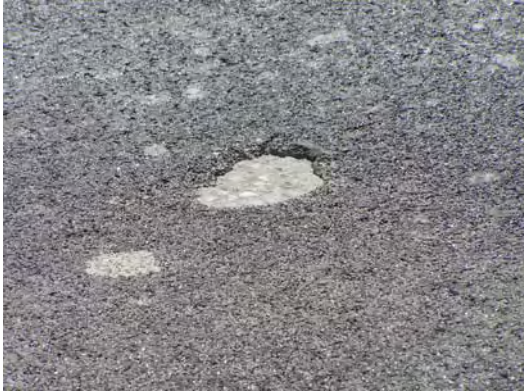
Delamination

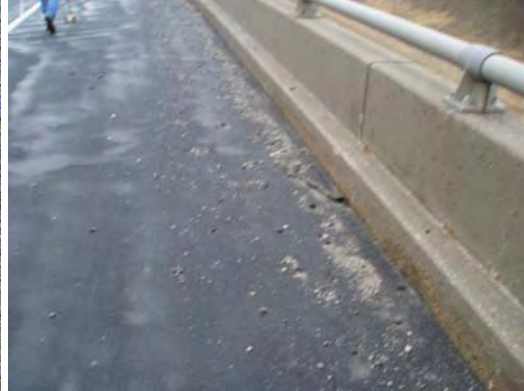
Peeling

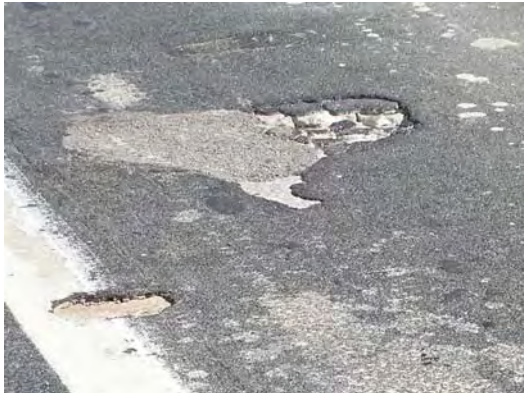
Sunken/cracked areas

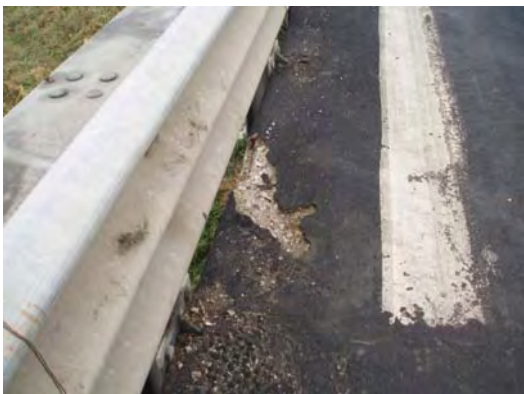
Spalling/loose areas

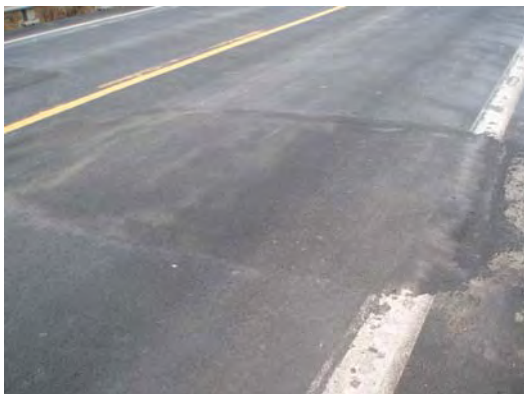
Post overlay Patches

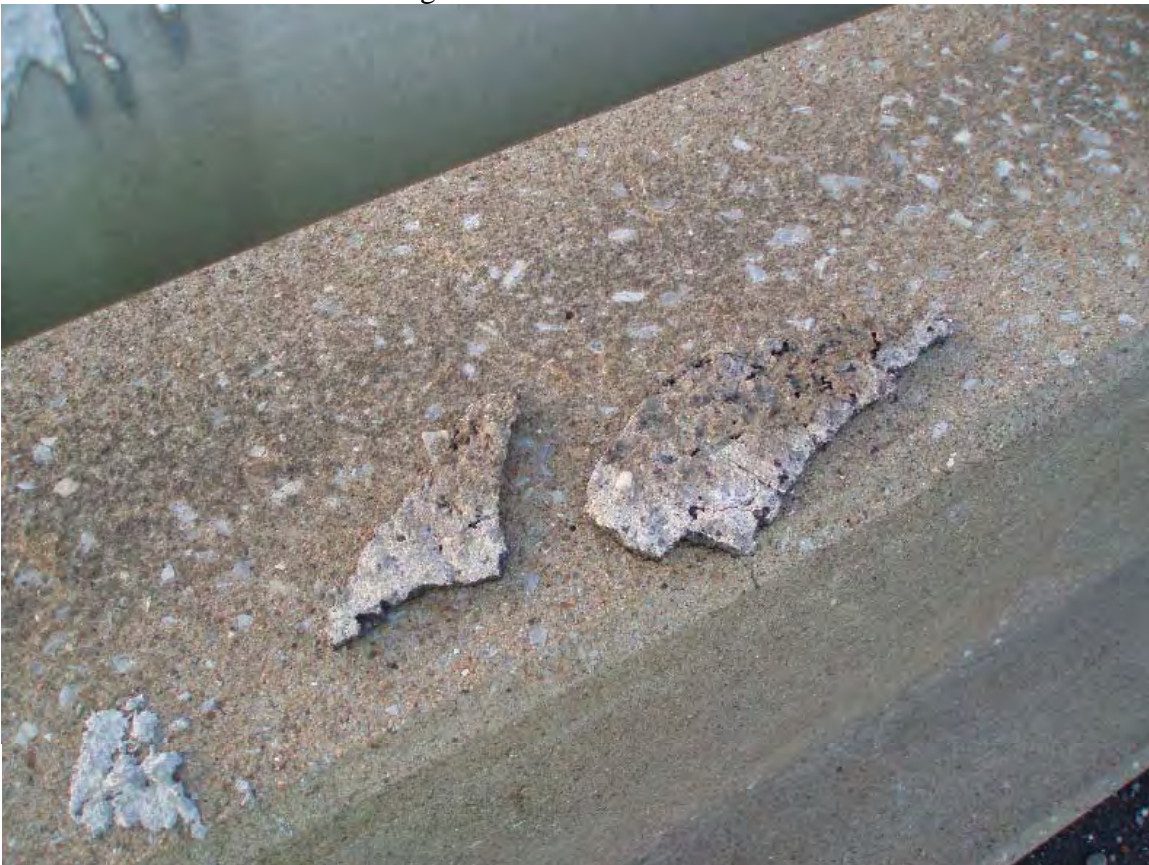
Epoxy polymer overlays are not a “repair” for bridge decks. They are only a means of protecting a deck that is in fairly good condition but is at risk for chloride and water penetration. Once a bridge deck has defects over a significant surface area, an EPO will not provide long lasting protection for the bridge deck and can even hamper repair efforts in the future. MoDOT’s Bridge Division generally recommends placing EPOs on bridge decks that are rated a 7 or higher and have less than 5% of the deck requiring repairs. Information gathered during the investigation indicated that many of the bridges that received overlays had significantly more than 5% defects. Many of the failures observed in the site visits appeared to be a failure of the top surface of the deck as opposed to a failure of the epoxy. Where possible, epoxy that had separated from the deck was examined. In most cases there was a layer of concrete paste on the bottom surface of the epoxy indicating that the epoxy had not debonded from the deck, but that the top surface of deck had delaminated. See Figure 1.

Figure 1. Epoxy Polymer Overlay that has concrete paste attached to the bottom

- While deck rating can be used as a screening tool, a deck evaluation should be performed on each deck prior to placing an epoxy polymer overlay. An EPO should not be placed if more than 5% of the deck requires repairs. It is also recommended to do a pull-off test on the bare deck along with chloride testing and checking for delaminations to ensure that the epoxy will not pull off the top layer of deck.
